Historic England

MAX FORDHAM

The Viability of Air Source Heat Pumps in Historic Buildings

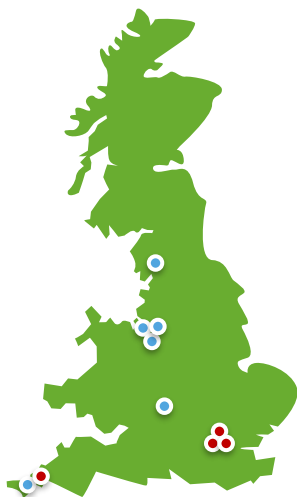
Figure 1 - Location of Case Study projects, Air-to-water (Monobloc) heat pumps shown in blue, Air-to-Air (Direct Expansion, DX) heat pumps shown in red

- Quarry Cottages, Residential, Chester
- Old Post Office, Residential, Chester
- The Old Coach House, Gym & Therapy Room, Chester
- St Anne's Church, Place of Worship, Cumbria
- Elizabeth Street, Optician, London
- Lowndes Street, Office and Shop, London
- Buckingham Palace Road, Office, London
- Holy Ascension Church, Place of Worship, Cotswold
- Little Trendal, Residential, Truro
- Plough Court, Residential, Truro

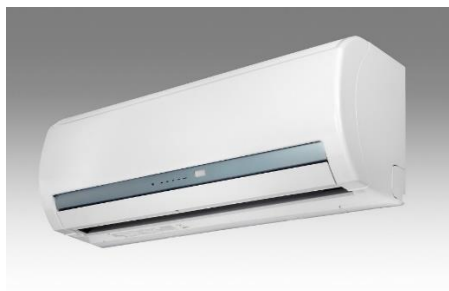
The remote condenser in a direct expansion system can interface with a traditional wet heating system via a heat exchanger or directly with the individual room heat emitters or "indoor units". Systems that use indoor units to deliver warmth are referred to as air-to-air heat pumps. See Figure 3 for an example of room mounted remote condensers often used with air-to-air heat pumps. Most air-to-air systems also allow the unit to be reversed and run in a cooling mode. Care would need to be taken to ensure overall energy consumption did not inadvertently increase by operating in cooling mode in summer.

Figure 3 - Example direct expansion indoor unit for heating and cooling

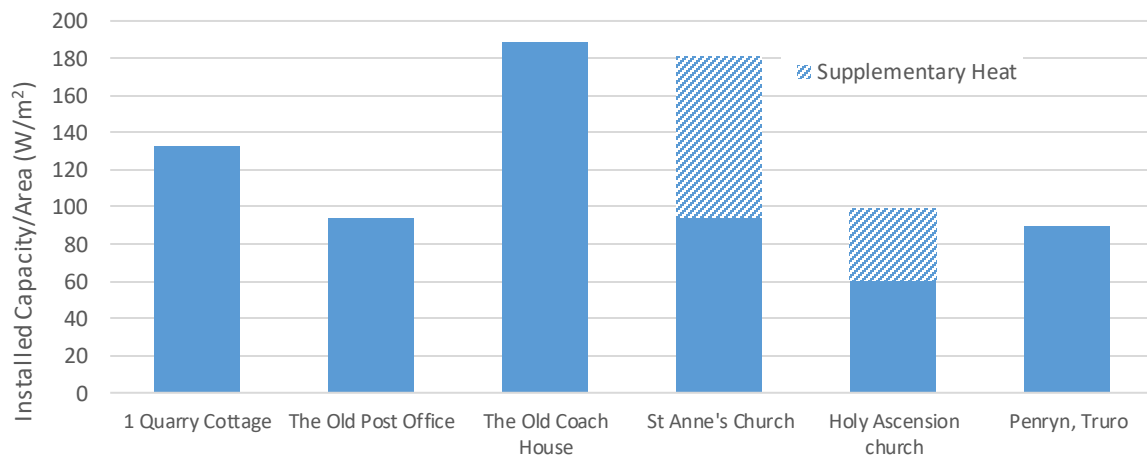
Figure 4 - Installed capacities of monobloc heat pumps

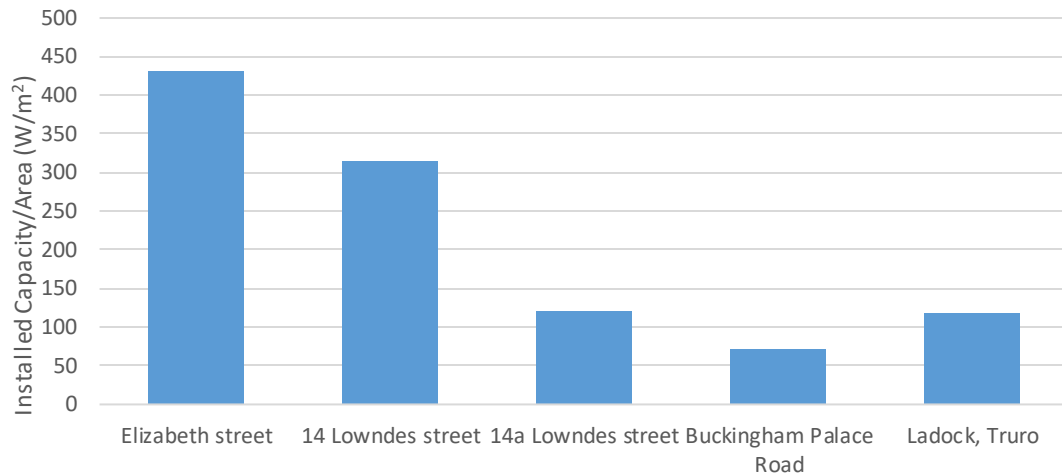
The capacities of Air-to-air systems tend to be larger as they are often sized to provide large summer cooling capacities. As the heating and cooling is provided by the same unit this artificially pushes up the installed heating capacity.

Figure 5: Installed capacities of direct expansion (air-to-air) heat pumps

Installed Capacity W/m ²	Expected Range W/m ²	Commentary
Elizabeth street	432	95 - 110	Cooling capacity dominant, driven by large shop windows.
14 Lowndes street (Shop)	316	95 - 110	Cooling capacity dominant, driven by large shop windows.
14a Lowndes street (Offices)	121	65 - 85	Cooling capacity dominant, driven by office heat gains in summer (lighting, IT equipment and people)
Buckingham Palace Road	112	65 - 85	Cooling capacity dominant, driven by office heat gains in summer (lighting, IT equipment and people)
Ladock, Truro	119	95 - 110	Correct sizing, lower capacity split units are not available.

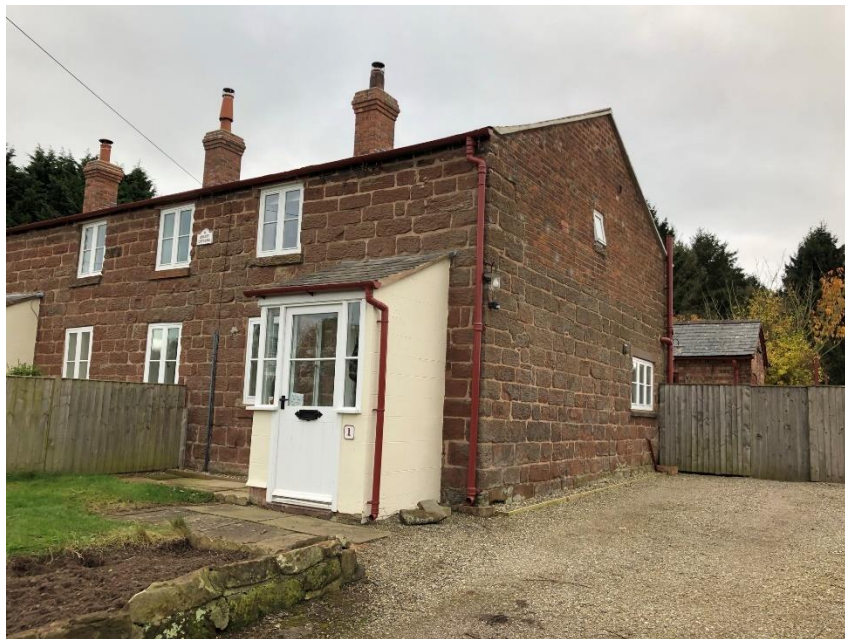
Figure 6: 1 Quarry Cottages.

1 Quarry Cottages is a two storey, two bedroom residential property belonging to the Grosvenor Estate that underwent significant renovations in October 2020. The works included the addition of internal mineral wool wall insulation to all external walls, as well as the installation of a monobloc 8kW Hitachi RASM-3RVE ASHP that distributes heat through a radiator central heating system. The ASHP also provides all of the domestic hot water (DHW) for the property, which is stored in a hot water cylinder. There is also a wood burning stove in the living room which serves as an additional heat source or backup. Previously the property was heated by electric storage heaters, which did not achieve comfortable temperatures.

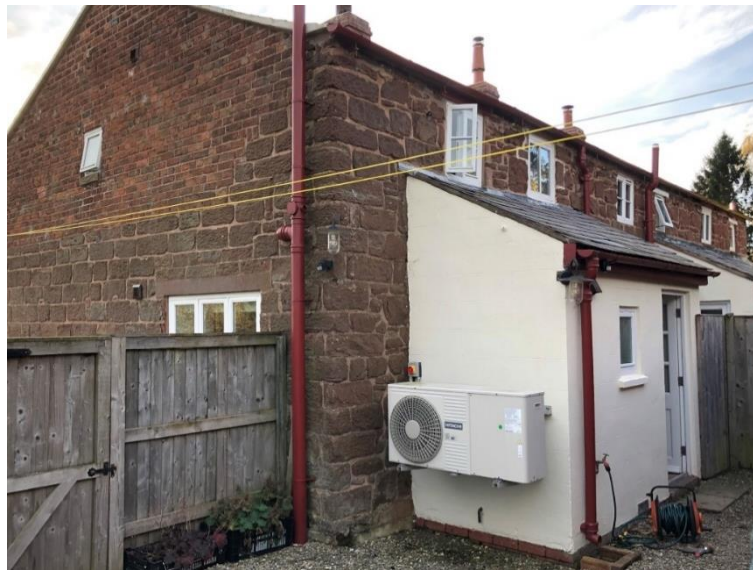
- Pipework is well insulated.
- The ASHP appeared to be cycling (operating for short periods of time and then switching off), which is an inefficient way for a heat pump to operate as the compressor does not reach its ideal operating conditions for long before switching off.

- On the day of the visit the outside temperature was approximately 12°C.
- During operation, the noise levels were in the expected range.
- During operation, the air speed at the ASHP outlet was found to be within the manufacturer's stated air speeds.

Figure 7: ASHP installation at rear of property

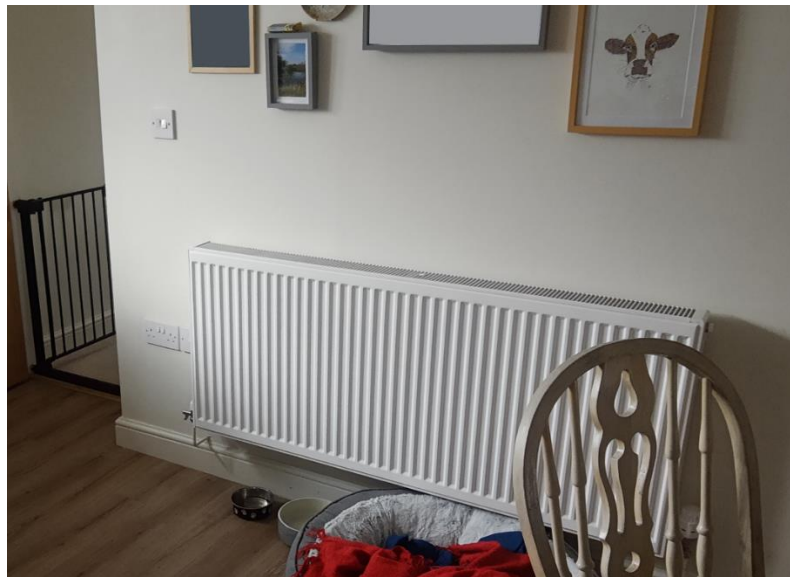
The radiator pipework was smaller than would be expected in best practice design. This may have led to other design decisions which impact optimum system performance.

Figure 8: Kitchen radiator with 10mm connecting pipework

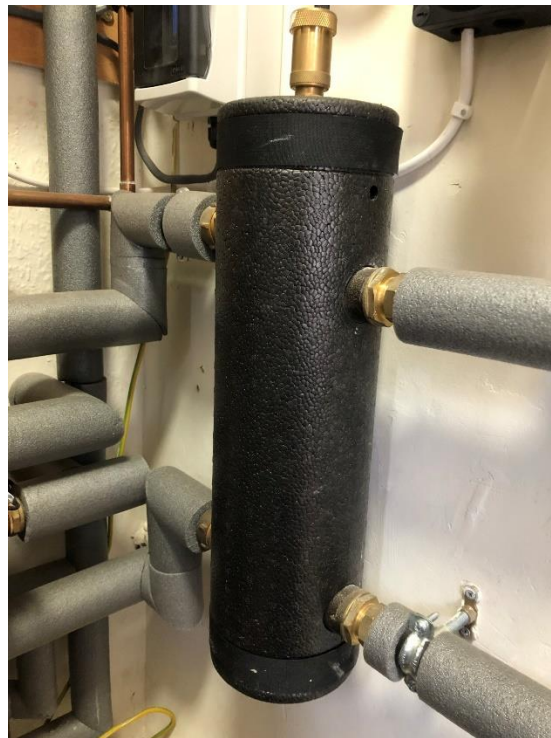
- This LLH may cause distortion of the flow and return temperatures, reducing efficiency.

Figure 9: Low Loss Header in the plant room

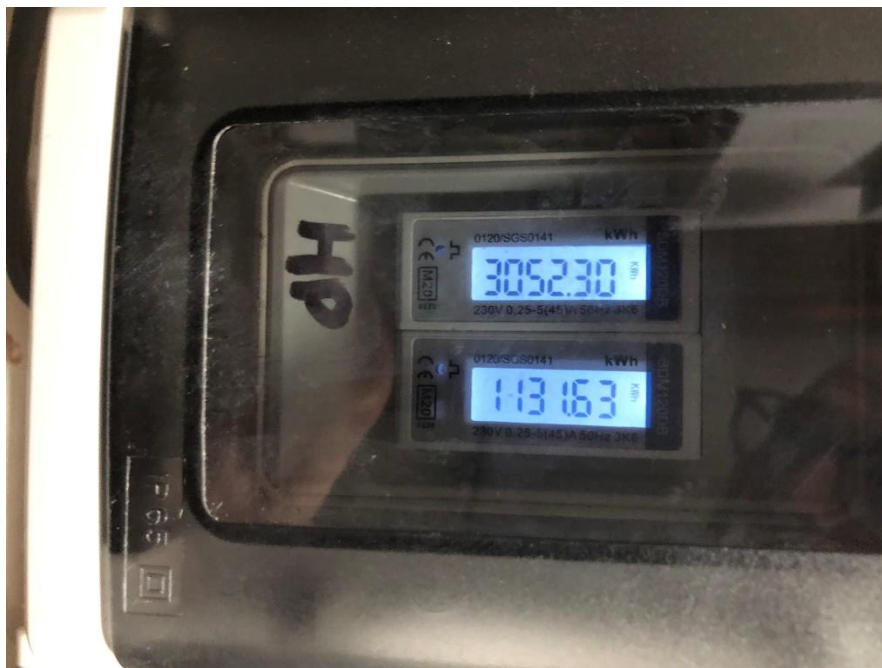
The heat pump was installed with a sub-meter to allow the electrical consumption of the heating system to be measured separately from the rest of the electrical demand at the property. This is an important feature to allow the tenant to understand where their energy demand is coming from. Figure 10 shows the meter reading as of 18/11/21. The total demand of the property from October 2020 to November 2020 was 4183.6 kWh. The heat pump accounts for 73% of the total demand. The bills provided by the tenant had significant time gaps so did not allow for an analysis of the real costs for this report.

Figure 10: Electricity meter, showing ASHP consumption at the top

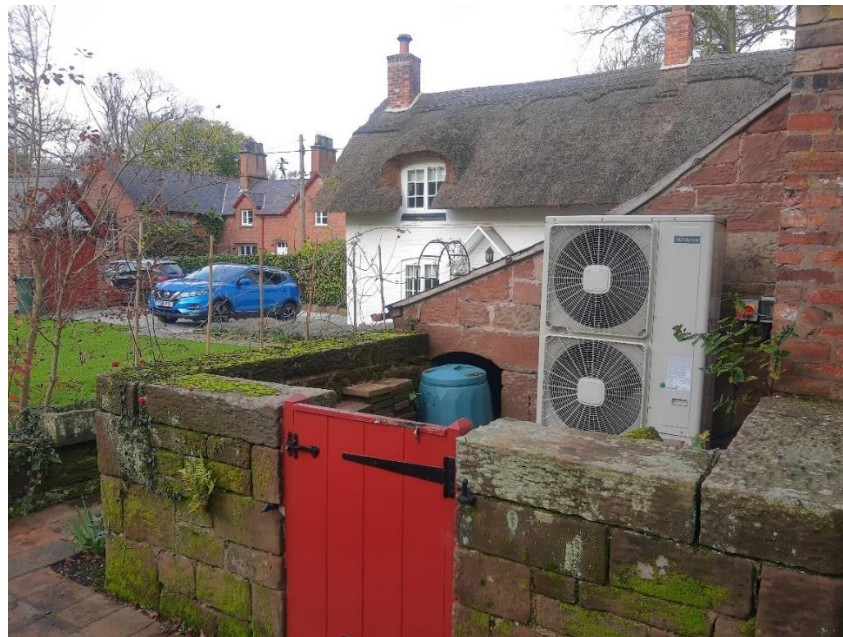
- Condensate drainage has been accommodated for with the ASHP installed above an existing drain, so there is no risk of freezing over walkways
- Outdoor pipework insulation has been severely damaged by birds, exposing the bare pipework in many places.

- The outdoor unit is sub-metered, allowing the energy consumption of the heating system to be separated from the rest of the property.
- The ASHP appeared to be cycling (operating for short periods of time and then switching off), which is an inefficient way for a heat pump to operate as the compressor does not reach its ideal operating conditions for long before switching off.

- On the day of the visit the outside temperature was approximately 12°C.
- The mean air speed at the ASHP air outlet was found to be within manufacturer's stated windspeeds.

Figure 12: ASHP at rear of property

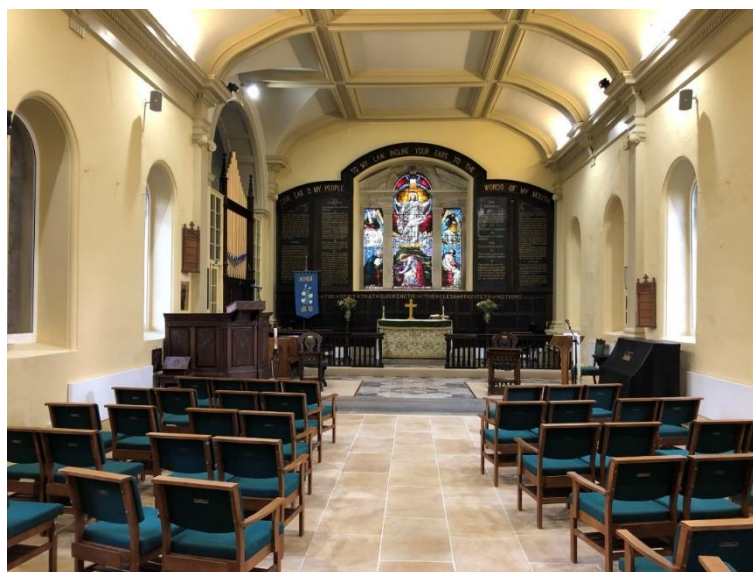
Figure 16: St Anne's Church (Interior)

St Anne's Church is a grade II listed building in Ings, Cumbria, dating back to 1743. It is owned by the Church of England. Previously the building was heated by direct electric under-pew heaters, which were quite comfortable when sat in the pews. The heating was only switched on 24 hours prior to Sunday gatherings, meaning that the building fabric remained cold, leading to condensation and cold draughts. In 2012 the church underwent major renovations, involving the installation of an 14kW underfloor heating ASHP system with 13kW of backup direct electric radiant wall panels. Fabric improvements were also made, adding floor and loft insulation, and secondary glazing. Since these renovations, a small extension to add a toilet was made, but this is not connected to the UFH heating circuit and instead is heated by a direct electric towel rail radiator.

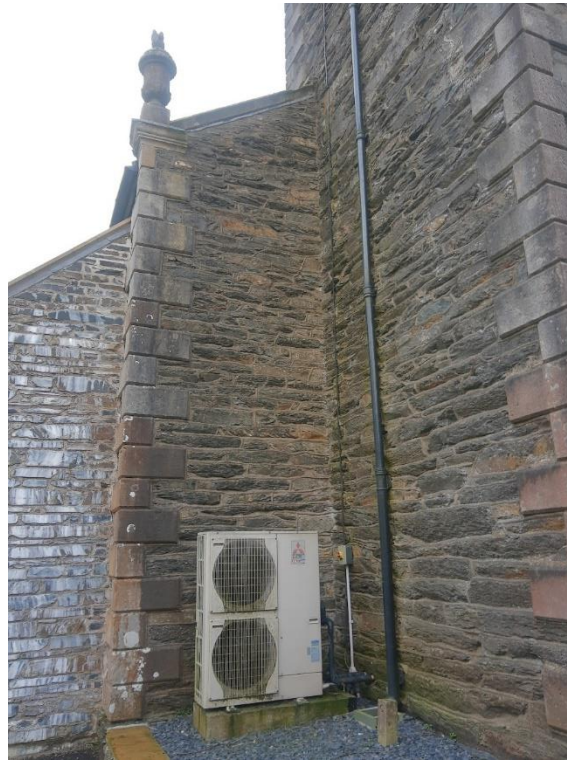
- The ASHP appears to be in good condition, with some exterior dirt the only sign of age.
- The mean air speed at the ASHP air outlet was found to be within the manufacturer's stated airspeed.

Figure 17: Mitsubishi Zubadan ASHP Unit at St Anne's

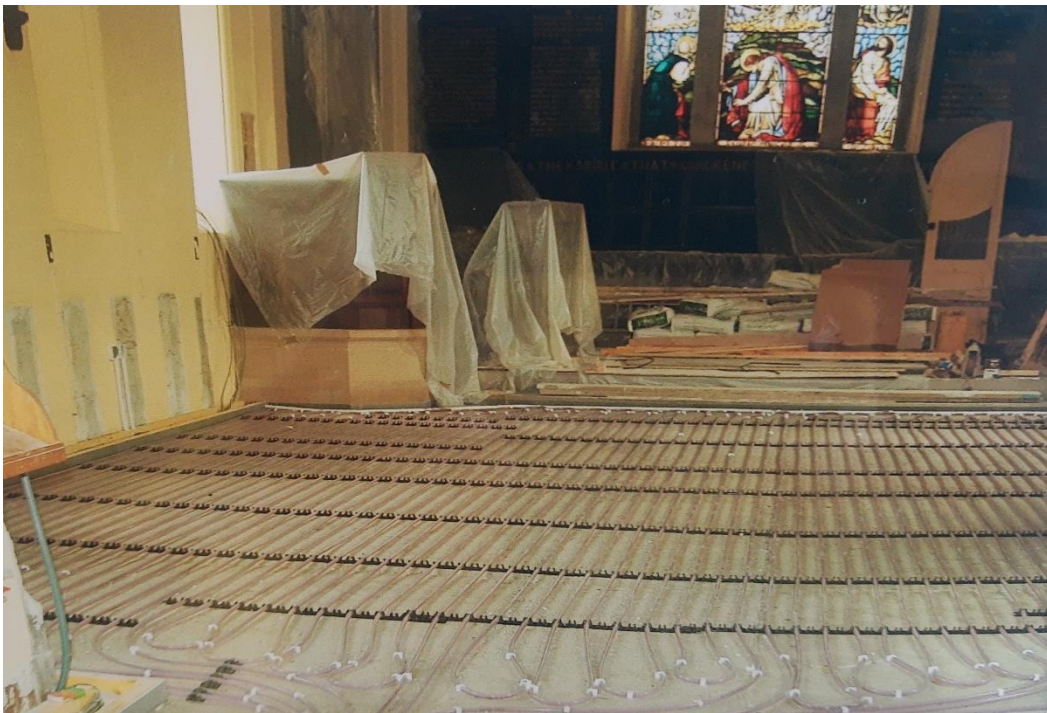
- The pipework, pumps and UFH manifold are easily accessed and neatly contained within a storage cupboard in the church porch.
- UFH heating circuit covers the main seating area, as shown in Figure 18.
- Pipework is well insulated, however many of the valves are exposed which will increase losses.
- The backup radiant panels are distributed though the nave and can provide heat in the case of extreme cold or heat pump failure.

Figure 18: UFH pipework being laid down during refurbishment works

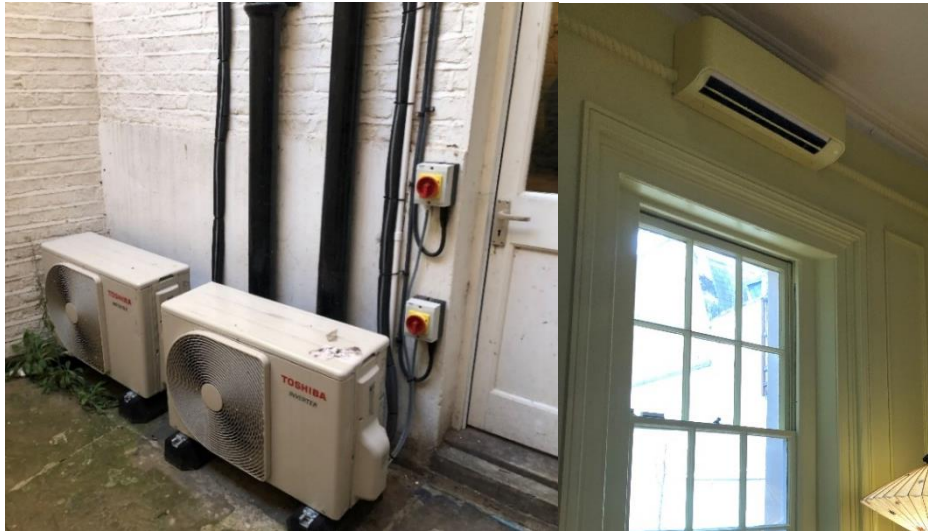
- Condensate drainage is allowed to run freely from the external units across the courtyard to a yard gully drain. In winter this may present a slip hazard.

- Pipework is well insulated against outdoor conditions.
- The external evaporator is piped with refrigerant to the internal condensers which runs vertically up the outside of the building before entering close to the location of the internal condenser.

- No measures have been taken to conceal the pipework and wires on the outside of the building, however the rear of the building is not overlooked.
- The indoor units have been painted to match the internal wall colour. They were therefore very discreet.

Figure 20 - ASHP installation at Elizabeth street. Left- External Units. Right- Internal unit, painted to match the internal décor.

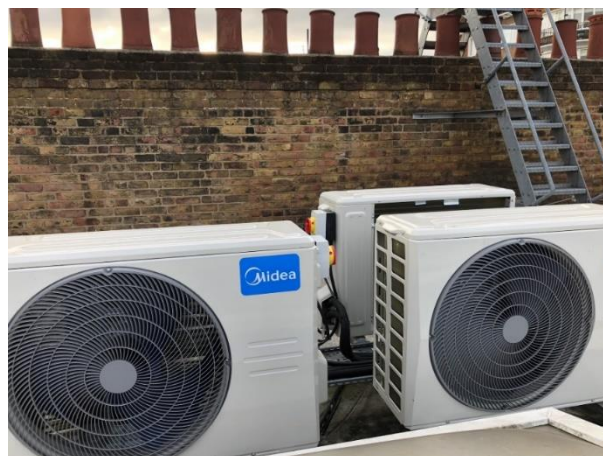
- Location hidden from the neighbours.
- Nearest noise sensitive location more than 5 m from units.
- Installed in accordance with manufacturer's installation requirements for access and airflow.
- No condensate drainage route was defined, water flows directly across the flat roof to the nearest roof outlet. This could present a slip hazard when frozen.

Figure 22 - ASHP units installed on the roof

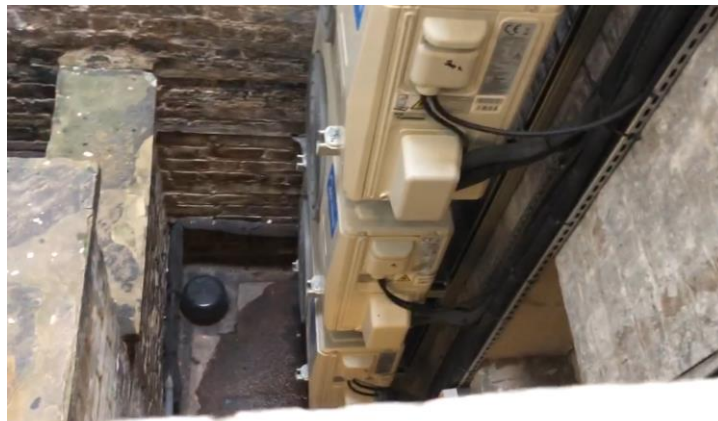
- Wall-mounted on brackets on a wall at the rear of the property.
- 1.8 m separates the face of the ASHPs with neighbouring single glazed windows. It is likely that any noise from these four units would be masked by the other noise sources in the vicinity. However, this should not be a reason to place units where they may cause a noise problem.

- Condensate drainage drops into the courtyard to run along the floor which might freeze in winter. This is not an issue as the area is not used for regular access.

Figure 23 - Wall mounted external units, with poor access and close proximity to neighboring windows

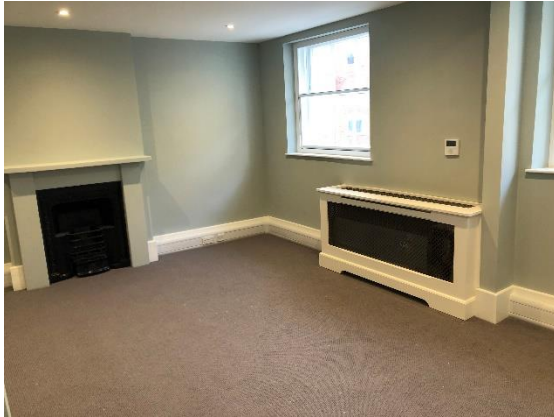
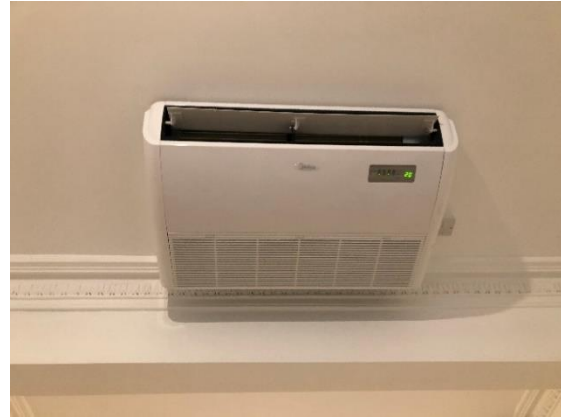
- Internal units are sympathetically installed with concealed pipework and custom made boxing around floor standing units.

Figure 24: Left: Floor mounted condenser. Right: Ceiling Mounted condenser

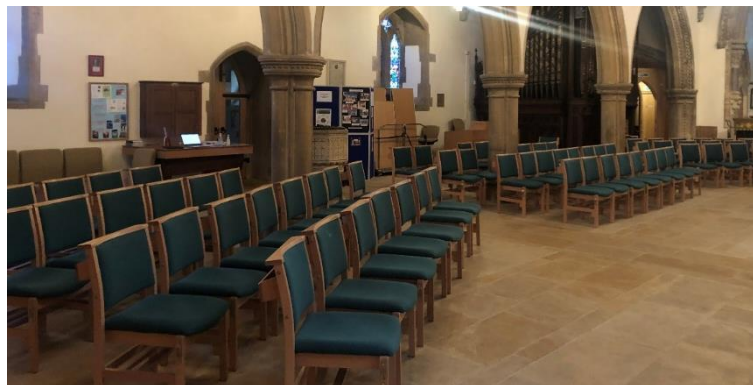
Figure 28 - Holy Ascension Church (interior)

One aim of the renovation was to increase the use of the church throughout the week by attracting community use. To increase the flexibility of the space the pews were removed and replaced with flexible seating. Previously the building was heated by an oil-fired boiler distributed through cast iron radiators and trench heaters. To support the aim of flexibility a new underfloor heating system powered by a monobloc (air-to-water) heat pump was installed.

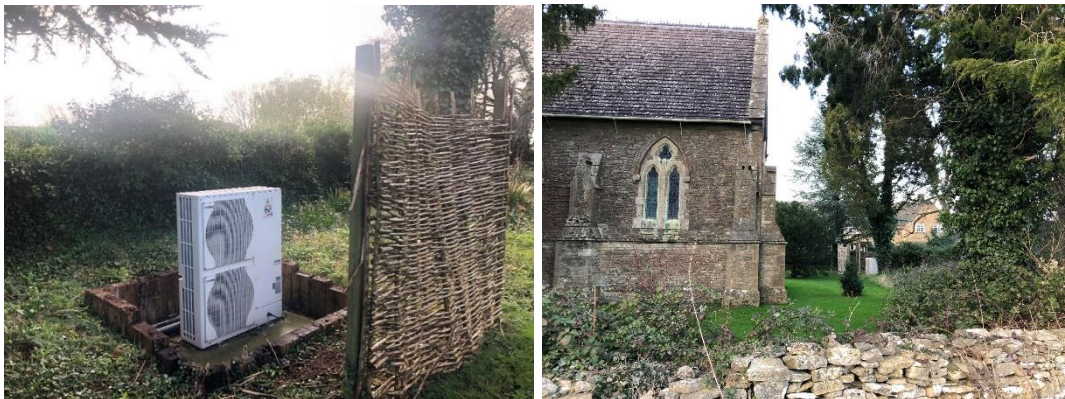
- The ASHP appears to be in good condition with normal levels of weathering for its age.

Figure 29 - ASHP external unit location, Left: close-up, Right: View from rear of grounds

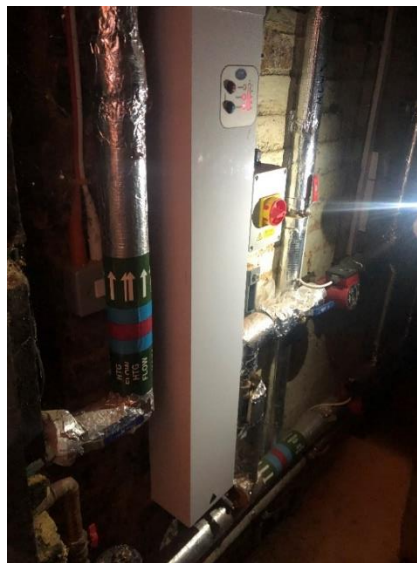
- It is likely that is a symptom of allowing the church to get cold during the week. If the heating was activated in autumn when the external temperature is mild and the stone walls and floor still retains some of the summer warmth the heat pump would be able to deliver heat without entering a defrost frenzy.
- The church custodians approached the original installer to remedy the situation. The installers solution was to install a 9 kW direct electric heater between the heat pump output and the underfloor heating input. A thermostat was set to activate this top up heater when the outside air temperature was below 5 °C.

Figure 30 – Inline Backup/Top-up direct electric heater

- This solution has, as far as anyone is aware, solved the issue of the heat pump entering a defrost frenzy.
- The combined output of the heat pump and direct electric heater can now provide 99 W/m² of space heating.
- The inclusion of a direct electric heater has significantly reduced the system COP. For example, a COP of +3.5 should be easily achievable by a modern heat pump. Combining the heat pump with a direct electric heater would lower the COP to around 1.6.

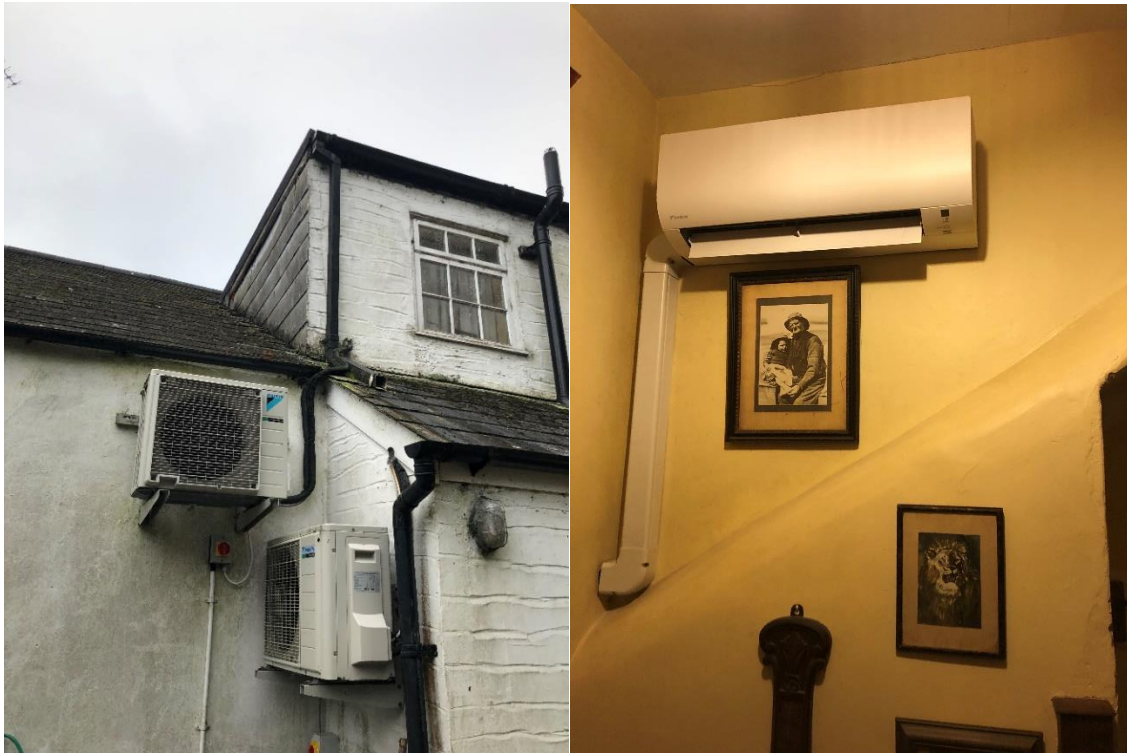
- The refrigerant is R410A, no low GWP alternative is currently available for small DX systems.
- The external units are installed on wall mounted brackets facing the driveway.
- Mounting position is elevated, protecting them from any potential flooding or snowfall.
- The location meets all of the manufacturer's installation space requirements for access and airflow.
- Pipework is well insulated.
- Condensate drainage from the external units is allowed to fall onto the driveway below. There is a land drain that the water makes its way to. Freezing could present a slip hazard, however, the user has never perceived this to be an issue as there is ample space to avoid the wetted section of driveway.
- The heat pump seems to be well designed and installed, with no need for maintenance since the installation.

Figure 32 – Left: ASHP units installed on the side wall of the property. Right: hallway condenser unit

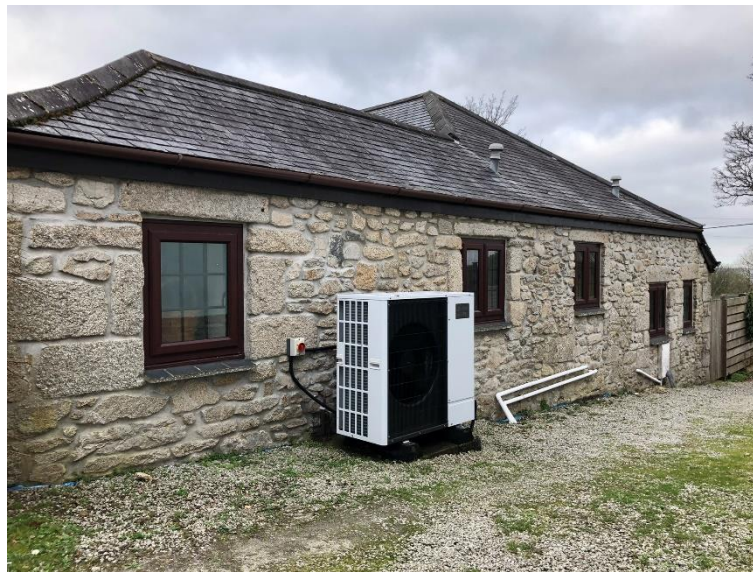
Figure 33 - Plough Court, monobloc AHSP located on old oil tank plinth

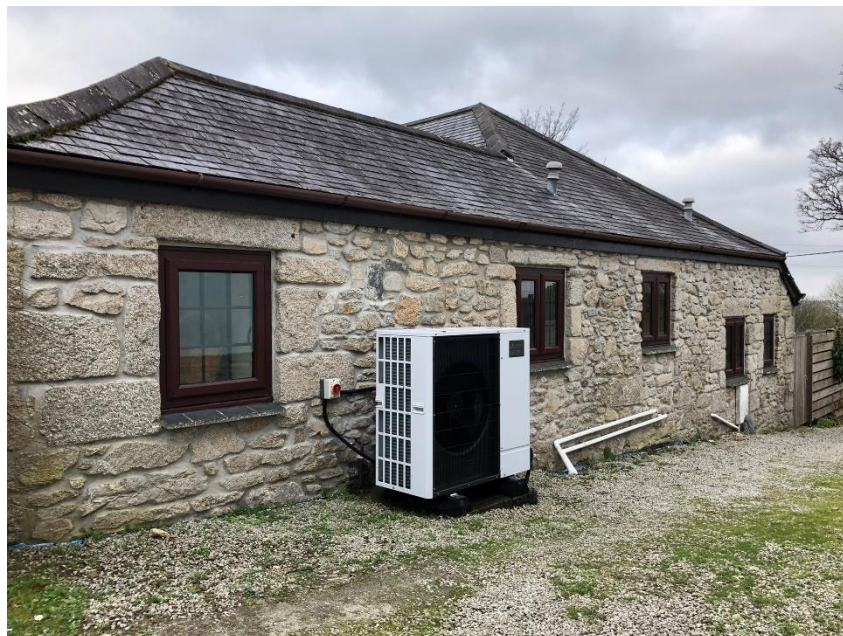
- The refrigerant is R410A, now being phased down.
- The ASHP is installed in the driveway of the property on a concrete plinth where the oil tank was located.
- The location meets all of the manufacturer's installation space requirements for access and airflow.
- No system buffer vessel is installed.
- The heat pump is quiet, and the closest noise-sensitive point is 8m away.
- Pipework is well insulated both externally and internally.
- Condensate drainage is allowed to disperse through the gravel driveway. No issues of freezing were reported.
- The ASHP is located around 2 m from the interior hot water cylinder.

Figure 34 - ASHP installed on the side of the property
